Ponencia 153 - B

AVOIDING EFFLORESCENCE ON EXTERNAL TILING THROUGH DESIGN AND CONSTRUCTION PRINCIPLES.

Colin Cass. B. Ed., Dip. T. (Technical)

Sydney Institute of TAFE, Sydney, Australia. colin@cass.org

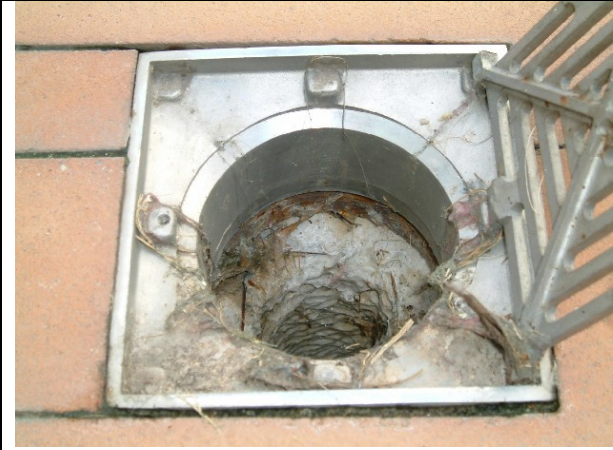
5. When the drain is open at the neck, and there is a gradient in the substrate to the drain, the efflorescence forms down the drain pipe and not on the tiles.

The key ways to dispose of (salt laden) water that has found its way into the mortar is to allow it to escape at the neck of any drainage grate or sump. In other words, do not allow the grate to be sealed to the membrane unless there are weep holes in the side of the grate. See **photo 5**. Also, ensure the capacity of the drain is sufficient to allow easy evacuation of surface water, or else back up water will re-enter the bedding system through the weep holes. Be aware that the diameter of the drain may decrease as salts build up in the pipe.

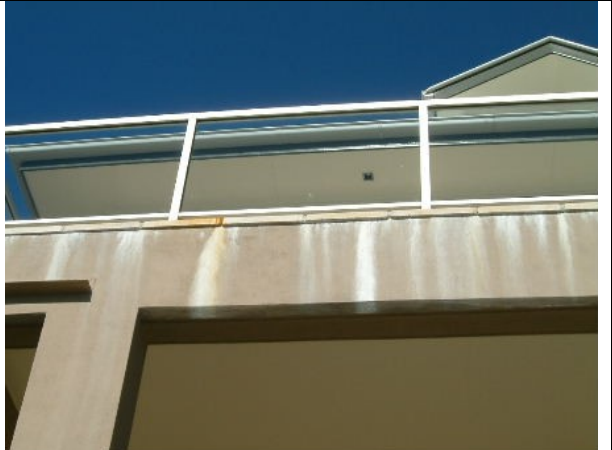
6. Where the gradient in the substrate leads to a free edge, efflorescence will form on the riser. To avoid this problem have a “waterstop” angle sealed to the floor at the edge or 1 tile in from the edge, and have the substrate behind the angle graded to a drain.

Do not allow substrate falls to go to a free edge unless the salt laden water is collected by a gutter, or unless the area is not going to be adversely affected by the appearance of efflorescence. (eg. a garden bed) **Photo 6**.

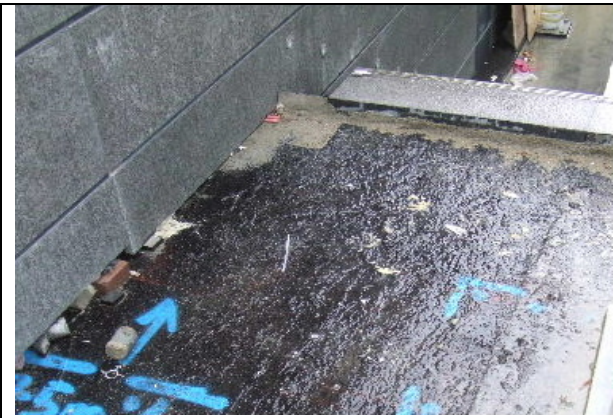
7. A gutter down the left edge of the stairs which contains drainage cell material under the tile, will see water from the landing take that pathway and stop it from emerging through the stair risers.

A “sealed in” “water stop” angle should be fitted at free edges and behind the nosing at the top of stairs, ensuring a positive fall in the substrate from the water stop to the drainage outlet. The vertical leg of the water-stop angle should finish flush with the surface of the tiling. (Waterstop angles are usually 90 degree extrusions of metal or plastic sealed to the surface or incorporated into the waterproofing system.) See **figure 4**. This will prevent water that enters the bedding on the deck from escaping over the free edge. Often on stairs, it is advisable to have a surface gutter run down the side of the stairs with a drainage cell beneath it, this way the only efflorescence that can form on the risers and treads is from the limited amount of calcium hydroxide available in the stair tiling. **Photo 7**.

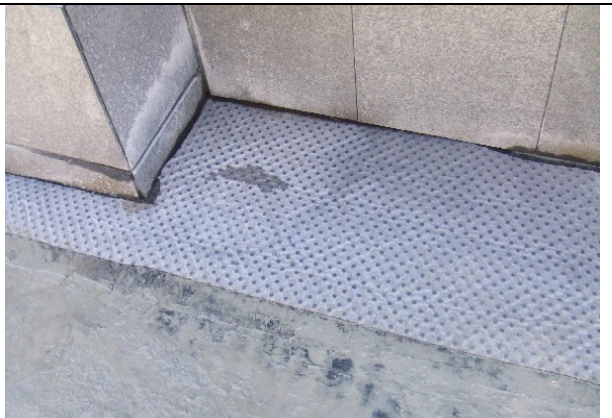
8. Drainage cell fabric under the tiling screed makes it easy to direct subterranean water to designated outlets.

As subterranean water will take the easiest path, in large areas, or where large volumes of subterranean water are expected, strips of drainage cell material can be placed on the waterproofing, beneath the screed to provide for easy movement of the water to the designated outlet. **Photo 8.**
